Corrosion Under Insulation

Spread of corrosion assessment for insulation systems in a high humidity environment with cycling process temperatures. **A test conducted by the world-renowned corrosion institute InnCoa.**

Spread of corrosion assessment for insulation systems in a high humidity environment with cycling process temperatures.

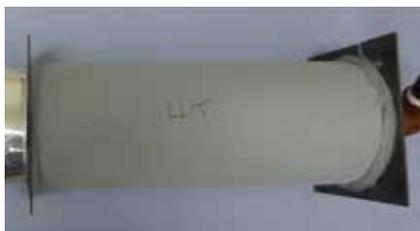
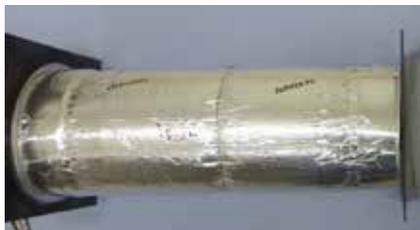
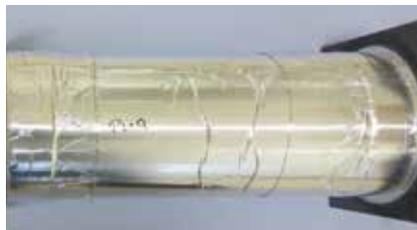
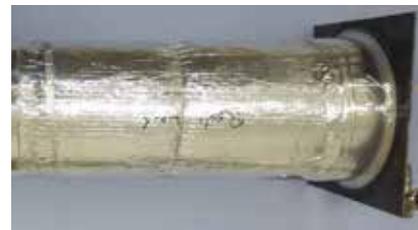
Sample A (ArmaFlex FEF)

Sample B (ArmaFlex FEF)

Sample C (Glass Fibre)

Sample D (PUR)

Sample E (Stone Wool)

Figure 4: Insulation systems installed on pipe sections.

- **Sample A:** Two layers of HT/ArmaFlex® Industrial flexible elastomeric foam (FEF) with flexible polymeric covering (Arma-Chek® R).
- **Sample B:** Two layers of HT/ArmaFlex® Industrial flexible elastomeric foam (FEF) with flexible polymeric covering (Arma-Chek® R). Each layer was applied with full adhesive coverage to the surface of the pipe and to the previously applied layer.
- **Sample C:** Glass fibre (Isover® Ultimate Protect 1000s) with factory applied aluminium vapour barrier foil.
- **Sample D:** Polyurethane (Korff® PUR RG40) with factory applied aluminium vapour barrier foil.
- **Sample E:** Stone wool (Rockwool® 800) with factory applied aluminium vapour barrier foil.

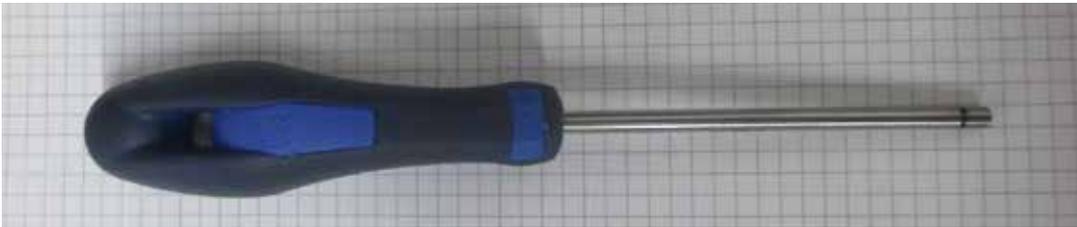
Figure 5: Tool to create punch holes in insulation systems.

The insulated pipes were installed in the climatic chamber on a wooden rack and interconnected with tubes for the water cooling/heating cycling. Surface damage to the insulation system was simulated by punching a 5 mm (0.20 in) diameter hole with approximately 10 mm (0.39 in) depth into the insulation and through the covering, using the tool shown in Fig. 5. The purpose of the punching was to simulate a discontinuity in the protective foil or Arma-Chek R covering layer, respectively and some damage to the outer portion of the insulation layer.

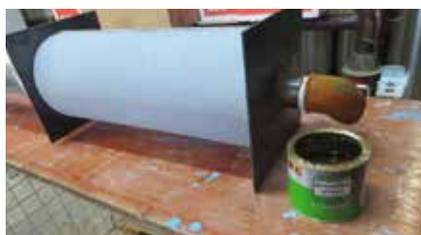
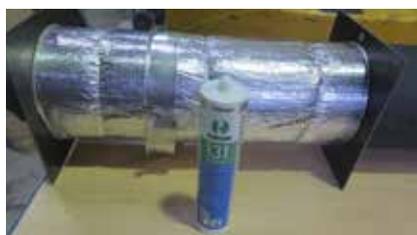
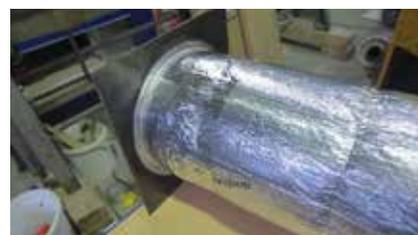
Samples A, B (FEF)

Samples C, D, E (Traditional)

Figure 8: Sealants applied to each system.

- **Samples A and B:** installed with ArmaFlex® Adhesive HT625 and Arma-Chek mastic sealant.
- **Samples C, D and E** (including factory applied vapour barrier collar) installed with a 50 mm (1.97 in) wide aluminium collar, aluminium tape and silicone sealant.

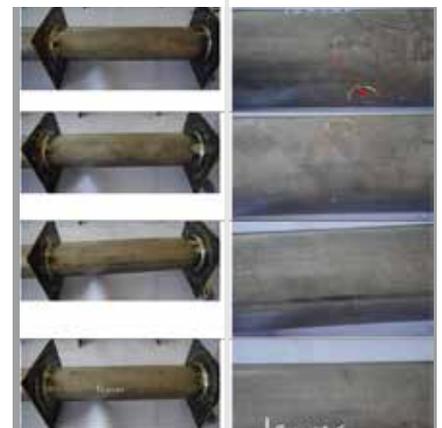
C

Figure 13: Pipe surface of Sample C, glass fibre, after 65 days.

The surface area of defects was between 1 and 5%. This resulted in a degree of protection rating, R_p , of 4 to 5.

It was observed that increased corrosion was detected on the pipework in the area under the damage hole. The analysis showed iron oxides with some silicon possibly coming from glass fibres, without any potential corrosion promoters such as chlorides.

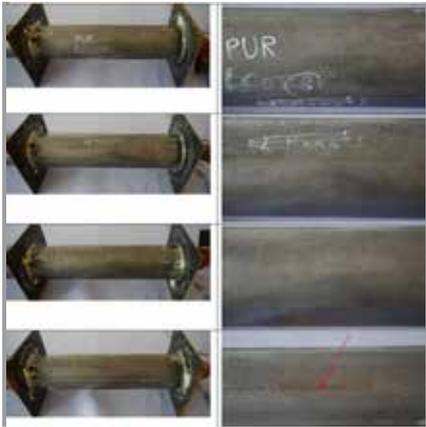
D

Figure 14: Pipe surface of Sample D, polyurethane, after 65 days.

The surface area of defects was between 1 and 2.5%. This resulted in a degree of protection rating, R_p , of 5.

It was observed that increased corrosion was detected on the pipework in the area under the seam of the insulation shells, which indicated that the seam may be a weak spot in this insulation system. The analysis of corrosion products showed iron oxides with a very small peak of silicon either coming from the polyurethane or from the pipe surface, without any potential corrosion promoters such as chlorides.
