MAKING A DIFFERENCE AROUND THE WORLD

CORROSION UNDER INSULATION (CUI)

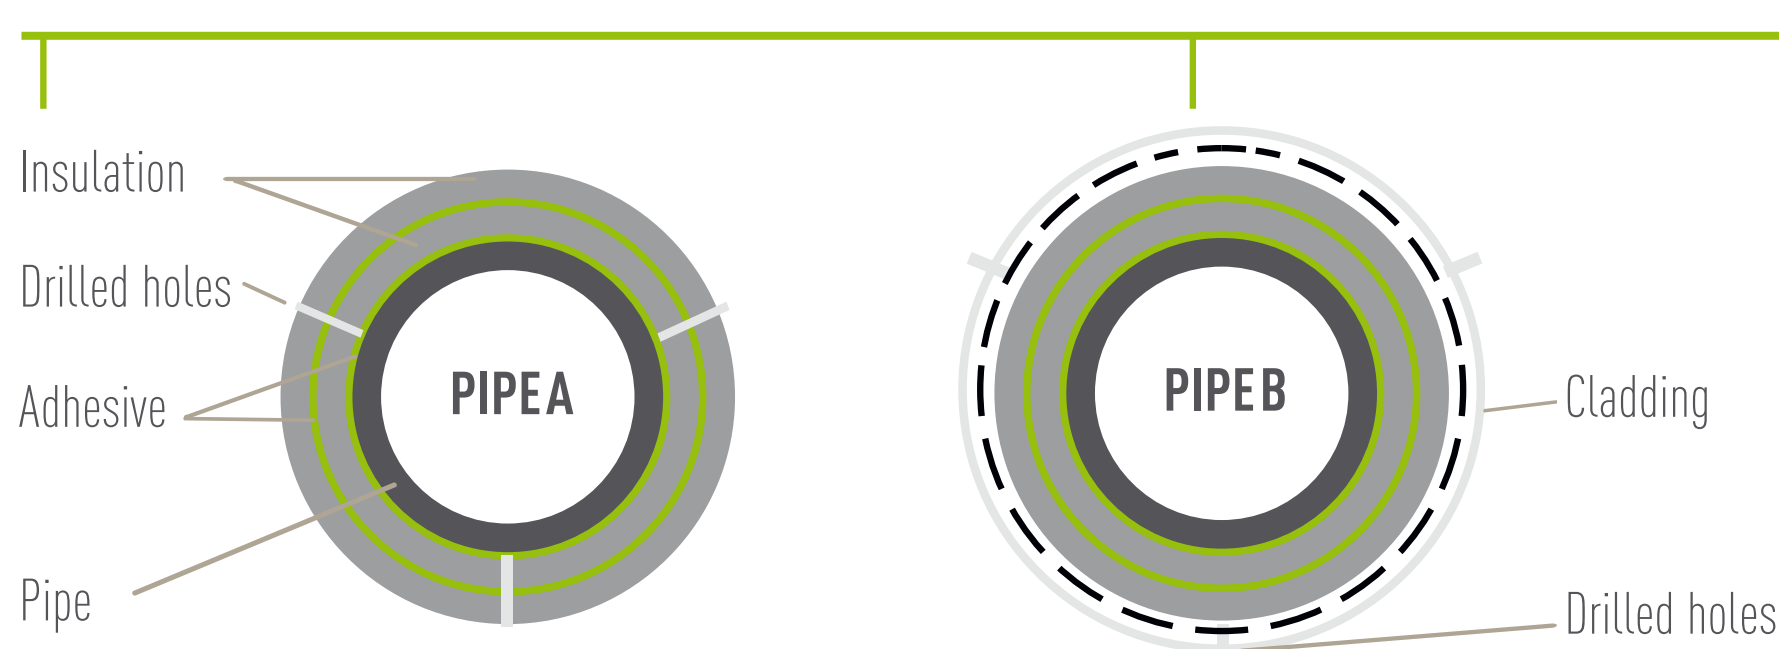
Corrosion experts, TNO/Endures, installed two pipes covered with ArmaFlex, one with GRP cladding and one without.

Insulation and cladding had holes drilled in different parts of the system.

35°C salt water sprayed onto pipes over 6 months.

Corrosion guaranteed to occur.

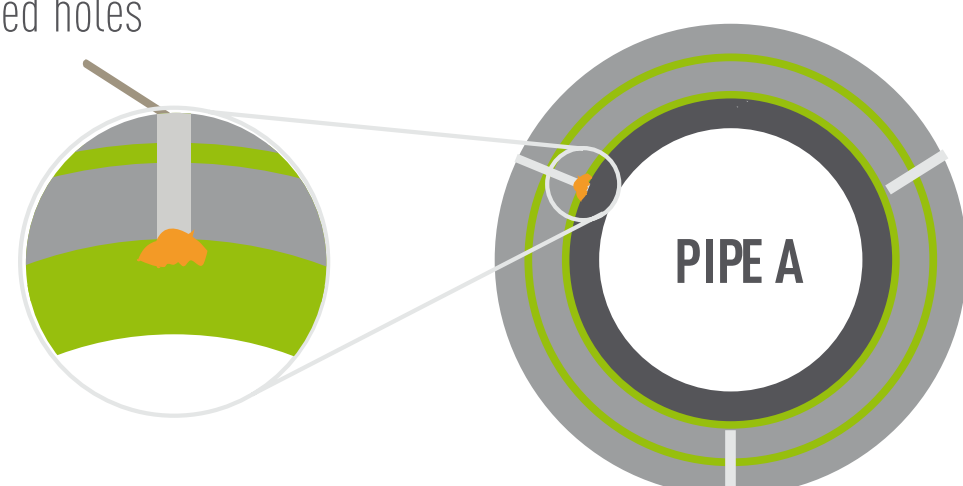
Drilled holes

Pipe A:

ArmaFlex closed-cell FEF material, used in combination with ArmaFlex adhesive, limits the spread of corrosion to areas just under the holes.

“No significant corrosion is observed in this area” says TNO/Endures

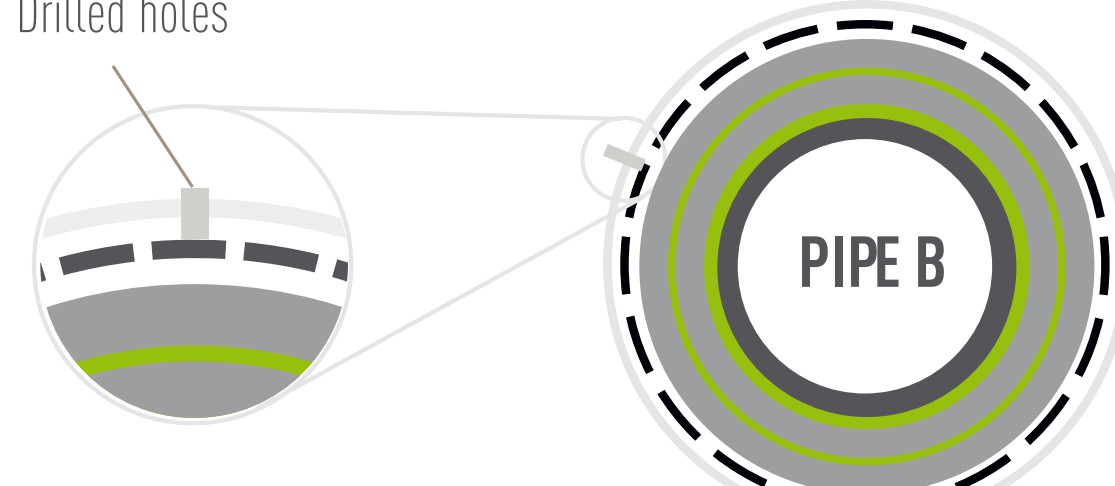
Drilled holes

Pipe B:

Water ingress did not penetrate the insulation.

“NO CORROSION” says TNO/Endures
