CORROSION UNDER INSULATION

OPEN CELL INSULATION REQUIRE EXTERNAL VAPOR BARRIER

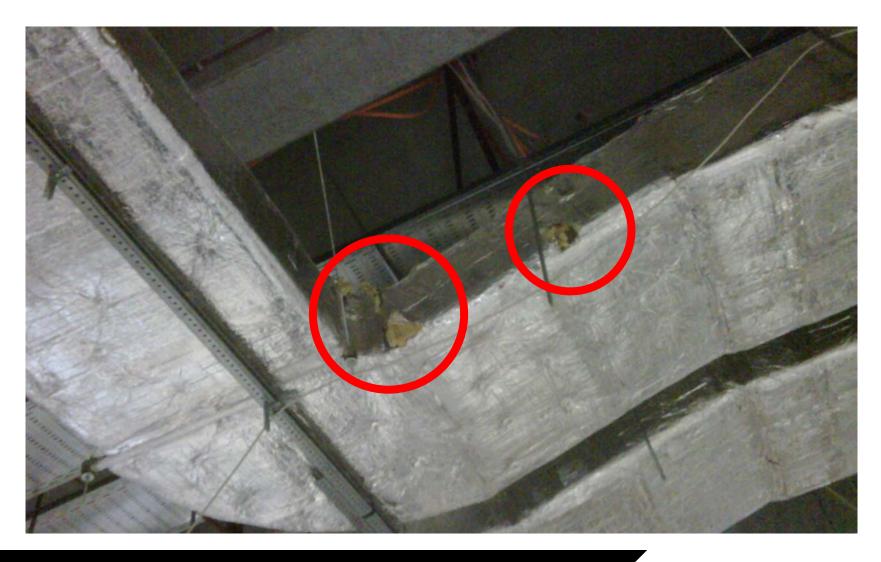
MOISTURE CAN SEEP IN AND SATURATE THE OPEN-CELL INSULATION MATERIAL

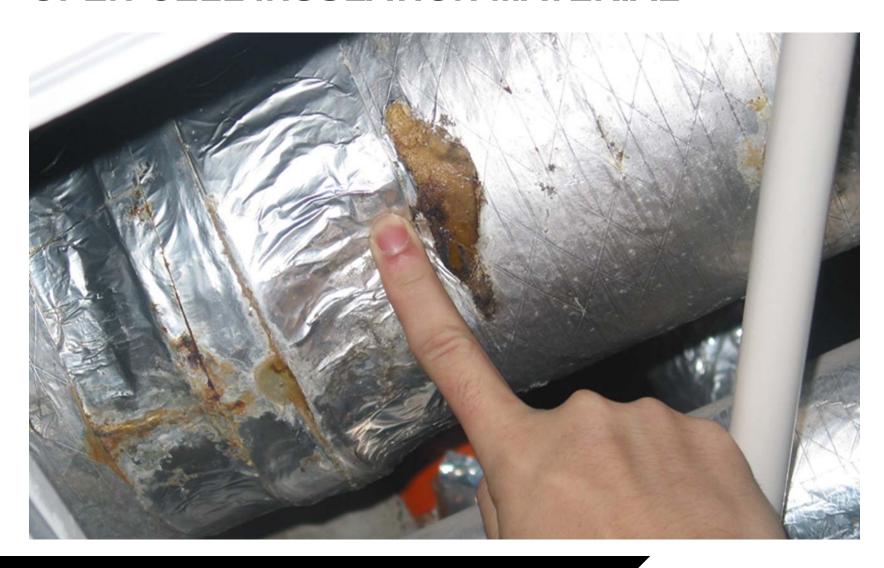
CORROSION DUE TO WATER VAPOR PENETRATION

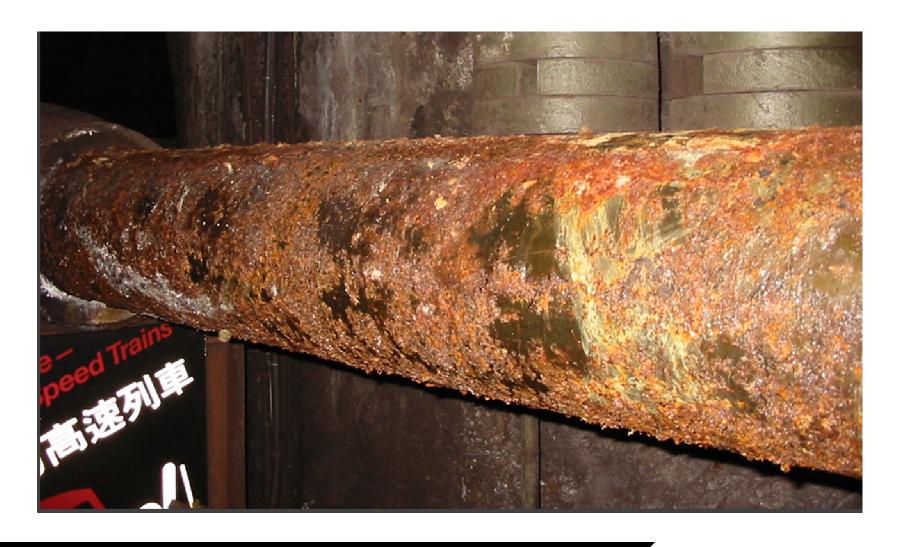
CORROSION DUE TO WATER VAPOR PENETRATION
