Quality characteristics of technical insulation materials:

Risk of Corrosion under Insulation (CUI)

ARMAFLEX INSULATION MATERIALS IN THE CUI ENDURANCE TEST

COMPARATIVE TEST OF DIFFERENT INSULATION SYSTEMS

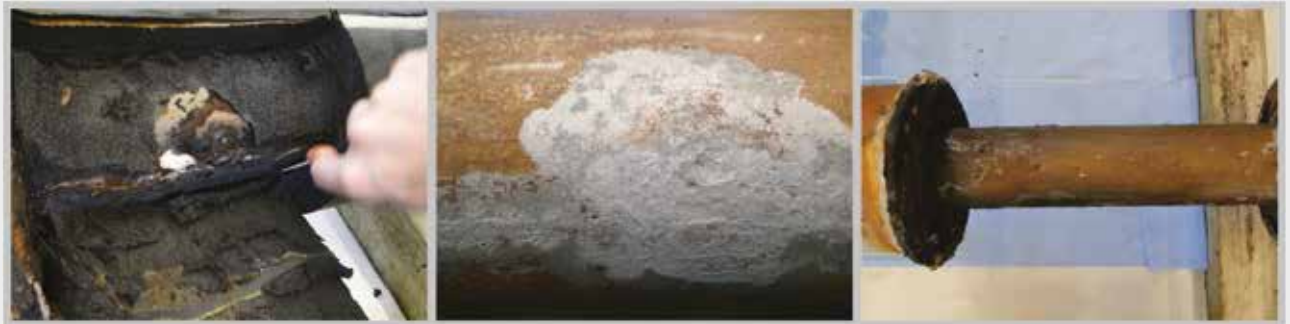
The deliberately induced corrosion in case A is only observed in the vicinity of the drill holes (see also the close-up). No traces of corrosion are to be seen in any other areas, such as the entire underside of the pipe (photo 3). Here the Armaflex insulation has prevented the spread of corrosion effectively.

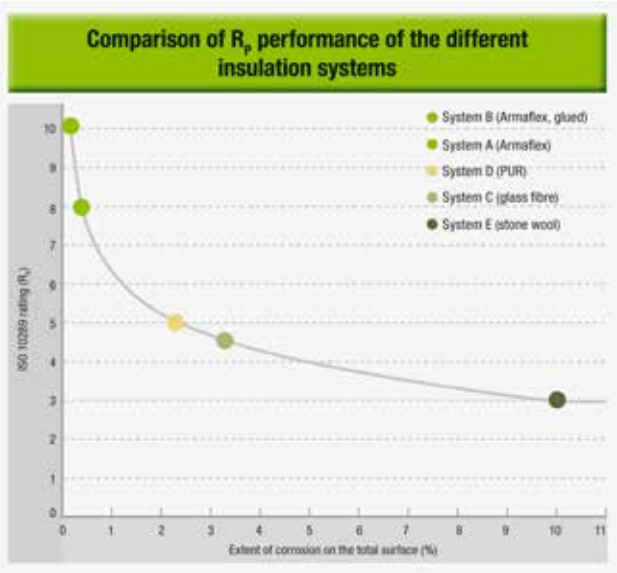
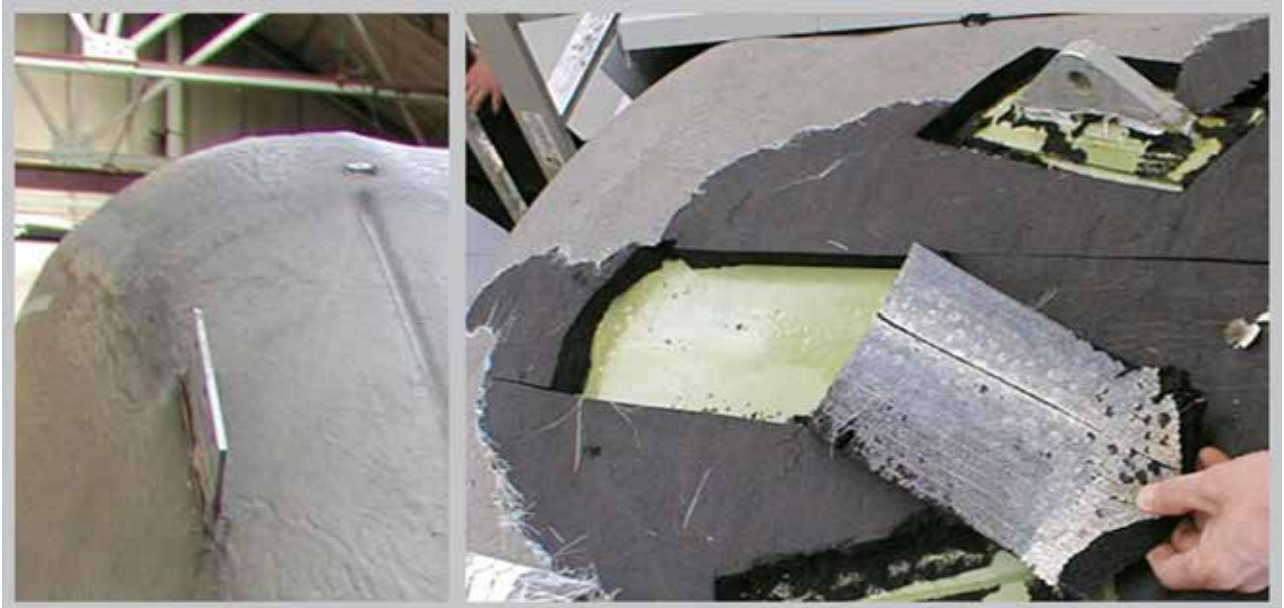
Armaflex insulation materials mitigate the risk of corrosion: whilst in service, the decompression chamber insulated with Armaflex and covered with Arma-Chek had regularly been exposed to green-water washover. After the chamber had been decommissioned the Armaflex insulation was cut open. As can be seen on the photograph on the right, the metal surface of the chamber is completely free of corrosion.
